NATURAL GAS DISTRIBUTION ACTIVITIES AFTER THE EARTHQUAKES ON FEBRUARY 6, 2023

GAZBİR-GAZMER R&D COMMISSION

MAY 2024

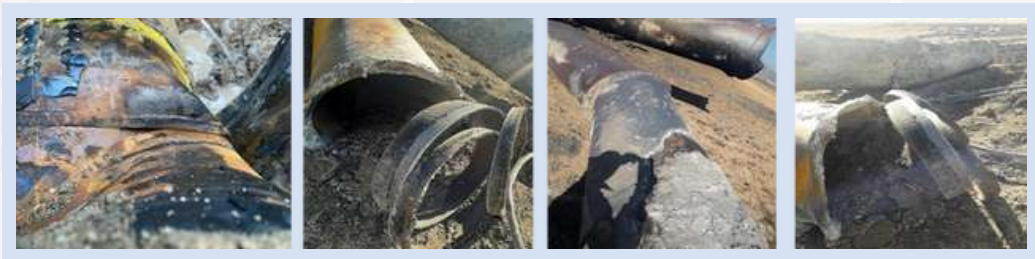
Figure 18: Post-earthquake pipe damages at RMS-A outlet

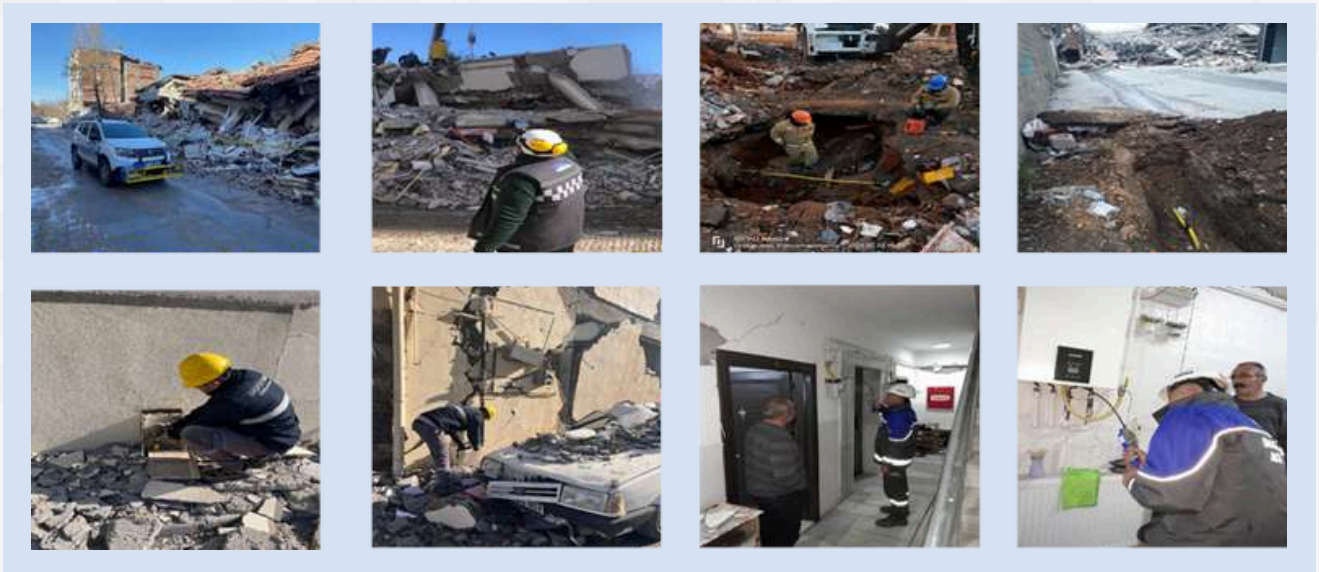
Natural gas distribution companies operating in the provinces in the earthquake zone and support teams from other provinces carried out network controls, capping works on PE lines, leakage search activities, building and apartment internal installation controls meticulously. Thanks to these works, buildings were safely re-gasified (Figure 21).

Figure 21: Natural gas distribution companies' leak detection and capping activities

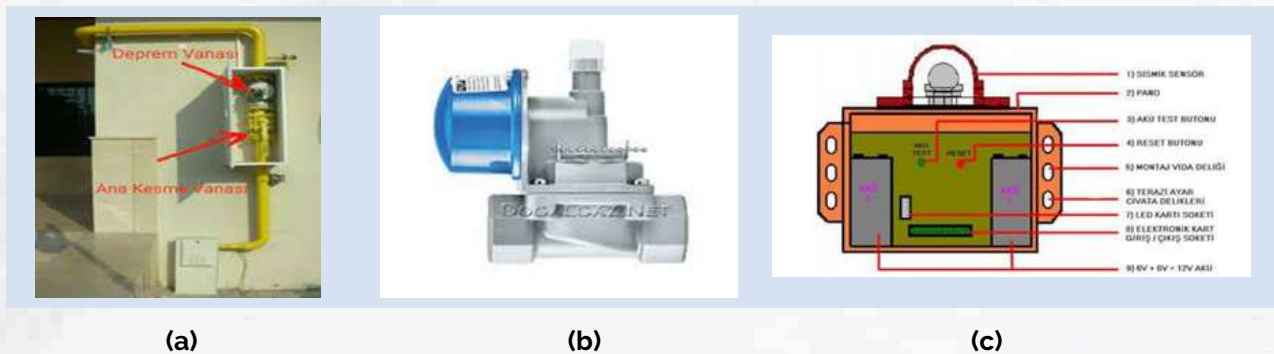
During the February 6, 2023 earthquakes, it was observed that some earthquake valves were not activated and did not cut off the gas flow to the buildings, the issue will be technically examined and initiatives will be taken before the Ministry of Environment and Urbanization and TSE to update the relevant standard.

Figure 24: (a) Installation representation, (b) Earthquake valve, (c) Earthquake sensor
