NATURAL GAS DISTRIBUTION ACTIVITIES AFTER THE EARTHQUAKES ON FEBRUARY 6, 2023

GAZBİR-GAZMER R&D COMMISSION

MAY 2024

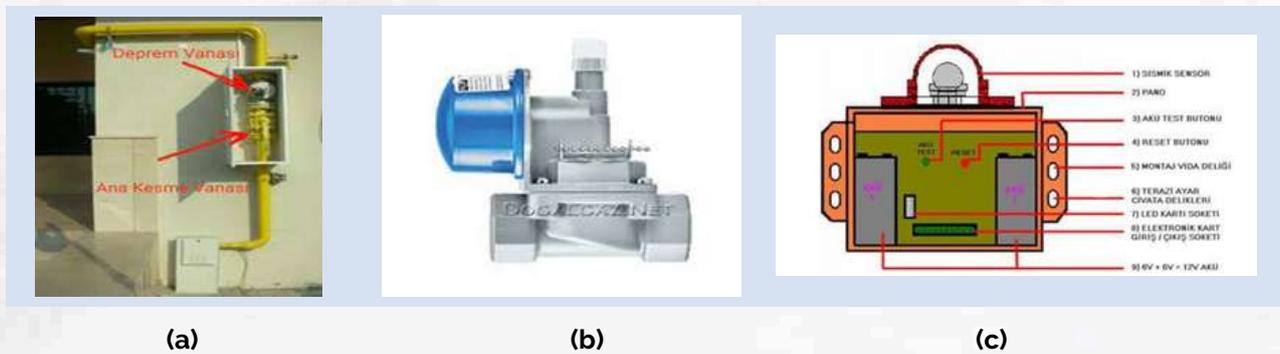
Figure 24: (a) Installation representation, (b) Earthquake valve, (c) Earthquake sensor

During the February 6, 2023 earthquakes, it was observed that some earthquake valves were not activated and did not cut off the gas flow to the buildings, the issue will be technically examined and initiatives will be taken before the Ministry of Environment and Urbanization and TSE to update the relevant standard.
