NATURAL GAS DISTRIBUTION ACTIVITIES AFTER THE EARTHQUAKES ON FEBRUARY 6, 2023

GAZBİR-GAZMER R&D COMMISSION

MAY 2024

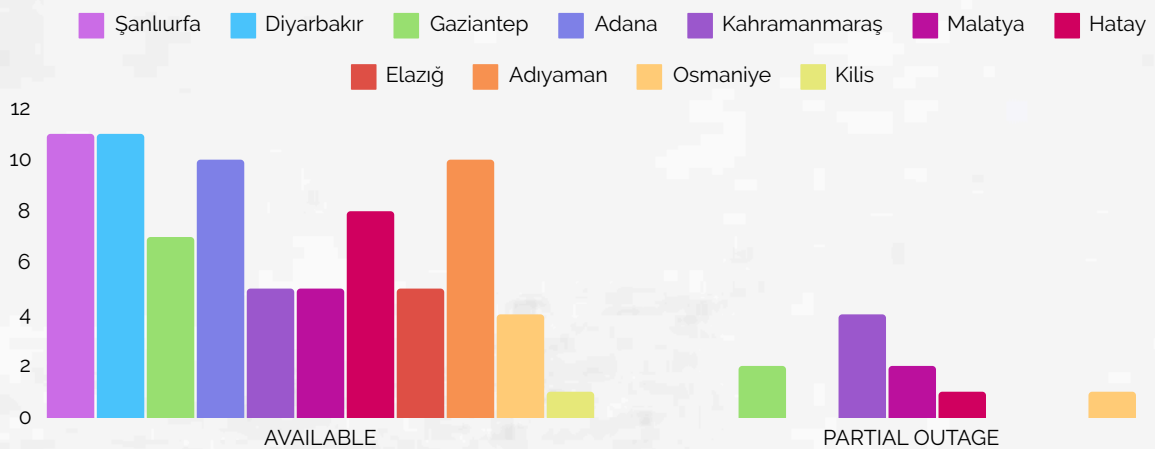
Figure 15: Steel line gassing status (number of districts/municipalities)

While 98% of the steel lines in 87 settlements (provinces/districts/municipalities) that use natural gas in the earthquake-affected regions were gasified after the earthquake, in 2 districts in the region (İslahiye and Nurdağı), there was a partial interruption in steel lines due to debris works and natural gas supply was ensured in the process (Figure 15).

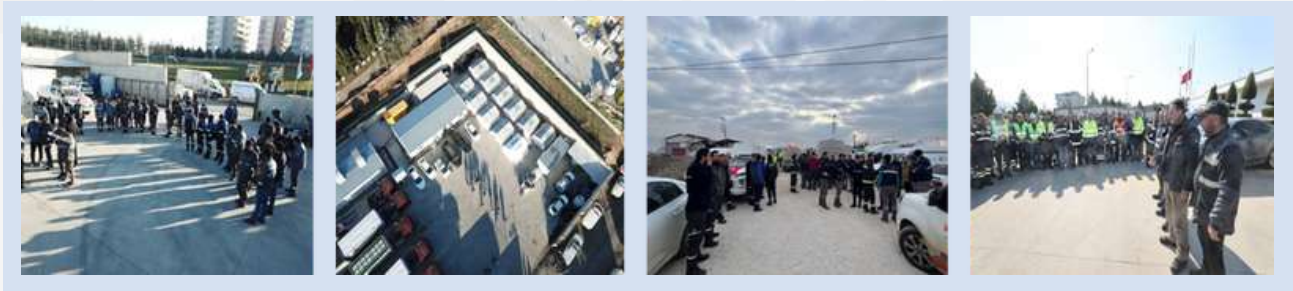
Figure 19: Activities of teams coming to the earthquake zone from other provinces

As of February 6, 2023, the first day of the earthquake, the personnel and vehicles of all natural gas distribution companies operating in 81 provinces were made ready to be dispatched to the region under the coordination of EMRA. The progress of the work in the region was monitored and support teams were dispatched to the region one by one as needed under the coordination of AFAD (Figure 19).

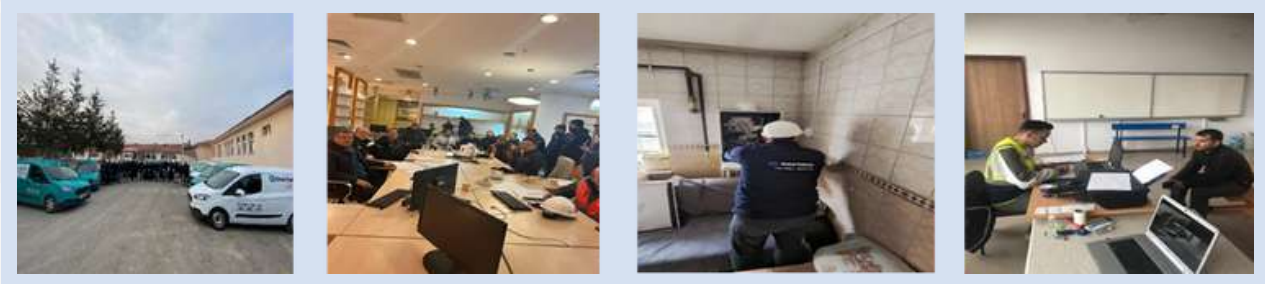
Figure 22: Gas burner device studies.

Companies that are members of the Natural Gas Industrialists' Association (DOSIDER) identified earthquake-related failures in gas appliances and provided spare parts and repairs free of charge.

7,200 service points were provided with device maintenance and parts replacement for 3,500 subscribers. Direct material support amounting to 15 million TL was provided by GAZBİR-GAZMER and DOSIDER.

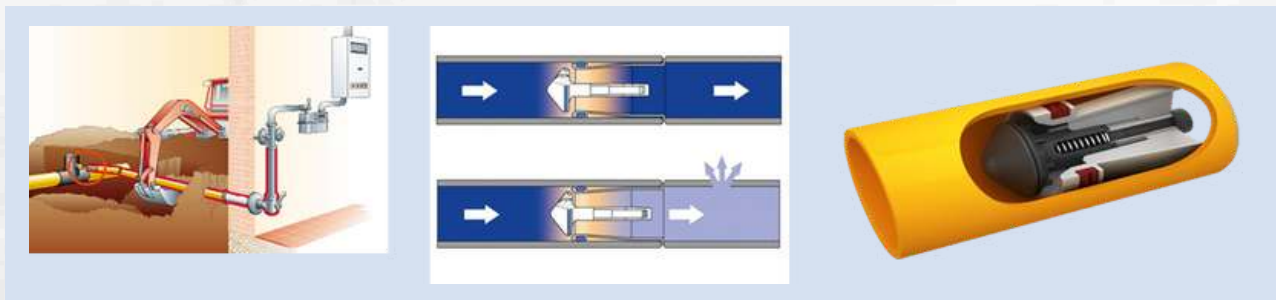
Figure 23: Gas-Stop equipment

Systems called Gas-Stop or Check Valve (Figure 23) are one-way safety valves that prevent the fluids passing through an installation from moving in one direction and returning back, thus enabling the system to operate more efficiently. Thanks to this system used in natural gas service lines, when a pressure drop occurs in the gas flow in the network for any reason, the system automatically activates and automatically stops the gas flow after the service box. The Gas-Stop application, developed to increase safety in natural gas lines, ensures safety by shutting off the gas flow in case of sudden flow rate changes in the subscriber connection lines of natural gas networks.

In addition to earthquakes, this technology also ensures the safety of the service line against threats such as landslides, floods, excavation works, service box damages, service box fires that threaten network safety. On February 6, 2023, earthquakes caused ruptures/punctures in the service lines of collapsed buildings, but secondary disasters (explosions/fires) were prevented thanks to the activation of Gas-Stop systems in the service lines.
