NATURAL GAS DISTRIBUTION ACTIVITIES AFTER THE EARTHQUAKES ON FEBRUARY 6, 2023

GAZBİR-GAZMER R&D COMMISSION

MAY 2024

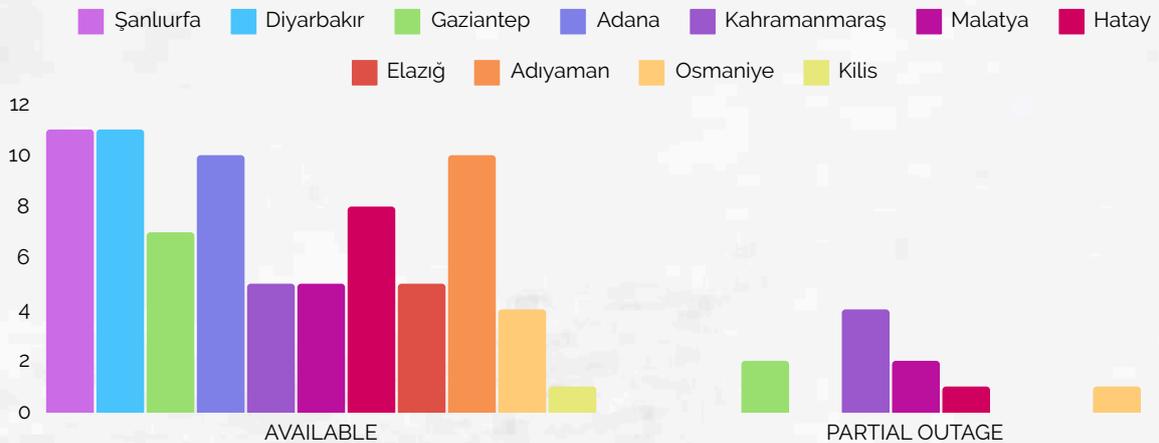
Figure 16: Polyethylene line gassing status (number of districts/municipalities)

Polyethylene line gasification rate was 88% after the earthquake. In 10 districts in the earthquake zone (İslahiye, Nurdağı, Antakya, Dulkadiroğlu, Onikişubat, Pazarcık, Türkoğlu, Battalgazi, Yeşilyurt, Doğanşehir), there was a partial interruption in polyethylene lines due to debris works and natural gas supply was ensured in the process (Figure 16).

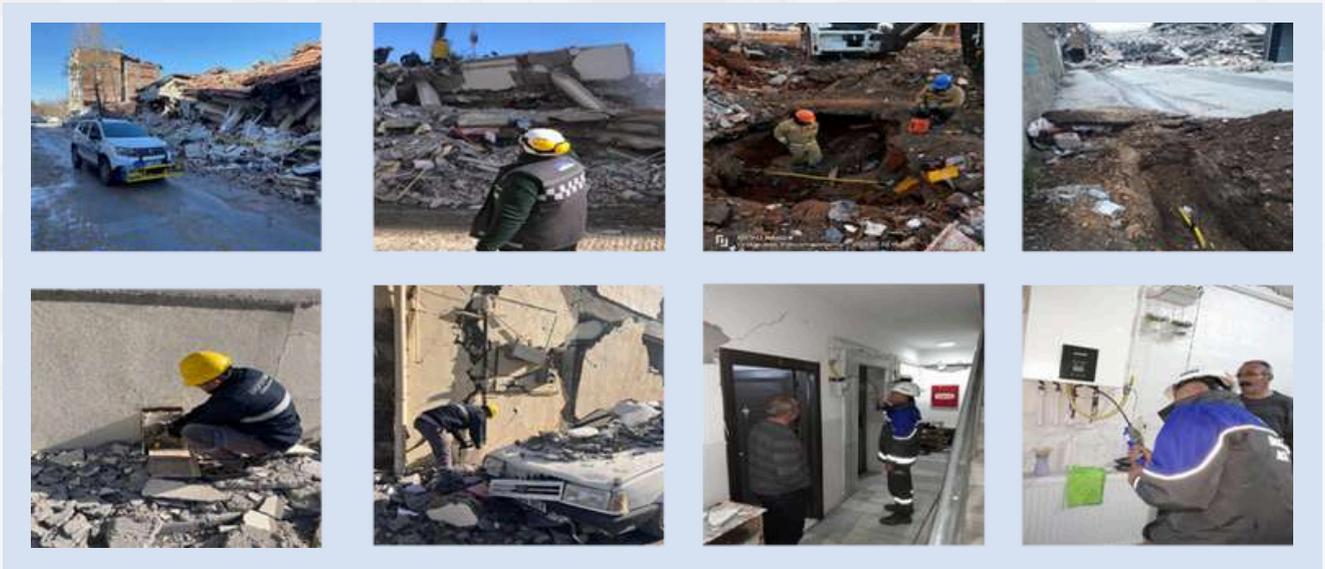
Figure 21: Natural gas distribution companies' leak detection and capping activities

Natural gas distribution companies operating in the provinces in the earthquake zone and support teams from other provinces carried out network controls, capping works on PE lines, leakage search activities, building and apartment internal installation controls meticulously. Thanks to these works, buildings were safely re-gasified (Figure 21).

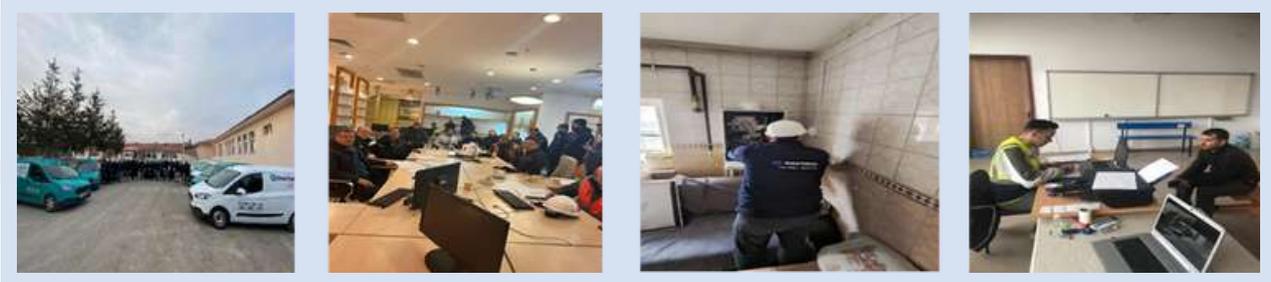
Figure 22: Gas burner device studies.

Companies that are members of the Natural Gas Industrialists' Association (DOSIDER) identified earthquake-related failures in gas appliances and provided spare parts and repairs free of charge.

7,200 service points were provided with device maintenance and parts replacement for 3,500 subscribers. Direct material support amounting to 15 million TL was provided by GAZBIR-GAZMER and DOSIDER.

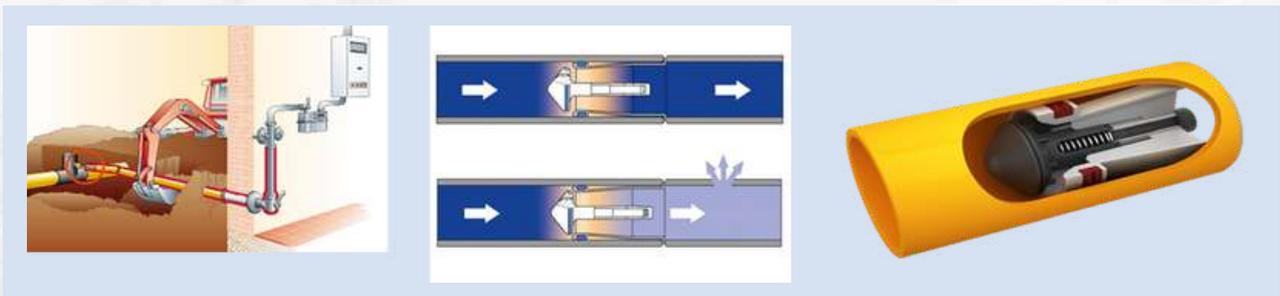
Figure 23: Gas-Stop equipment

Systems called Gas-Stop or Check Valve (Figure 23) are one-way safety valves that prevent the fluids passing through an installation from moving in one direction and returning back, thus enabling the system to operate more efficiently. Thanks to this system used in natural gas service lines, when a pressure drop occurs in the gas flow in the network for any reason, the system automatically activates and automatically stops the gas flow after the service box. The Gas-Stop application, developed to increase safety in natural gas lines, ensures safety by shutting off the gas flow in case of sudden flow rate changes in the subscriber connection lines of natural gas networks.

In addition to earthquakes, this technology also ensures the safety of the service line against threats such as landslides, floods, excavation works, service box damages, service box fires that threaten network safety. On February 6, 2023, earthquakes caused ruptures/punctures in the service lines of collapsed buildings, but secondary disasters (explosions/fires) were prevented thanks to the activation of Gas-Stop systems in the service lines.
